Water Pump Drive Sprocket Removal & Fitting Kit - for

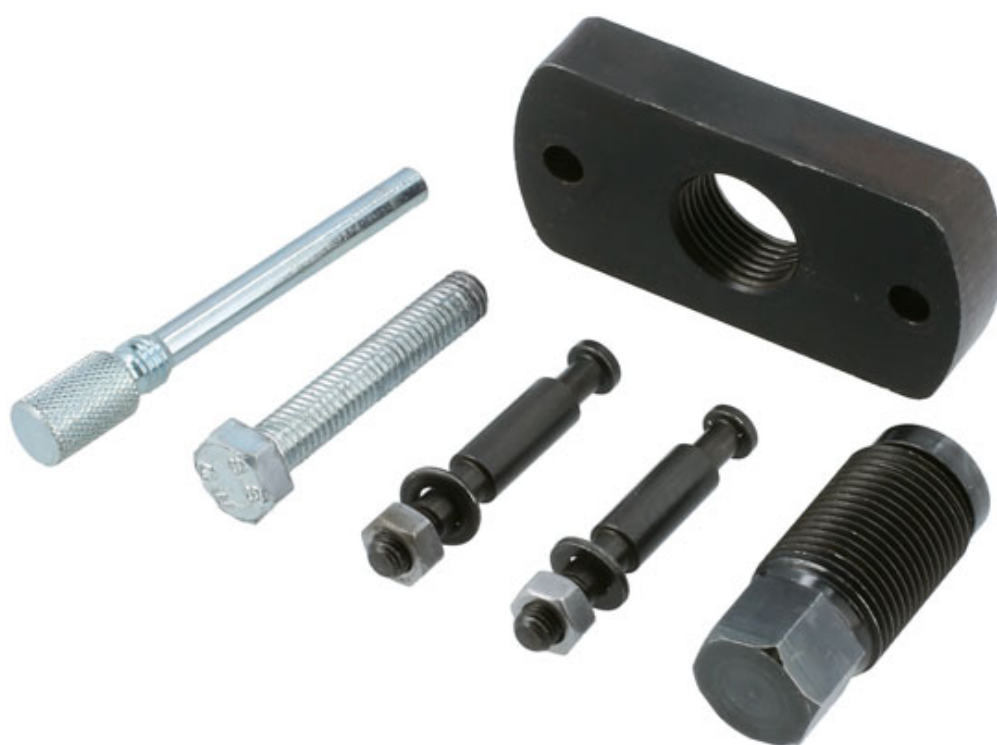
The VW group 1.5 TSi engines use a water pump that is belt driven via the inlet camshaft. When performing engine timing checks or timing belt replacement, it is necessary to remove the water pump and the drive sprocket from the end of the camshaft. Removal and fitting of the sprocket must be done in a controlled manner that does not pull or push on the internal camshaft components and the sprocket must be correctly aligned when being fitted. The Laser 8956 kit has been designed to do removal, fitting and alignment of the sprocket using force screws to ensure the camshaft is not pulled or pushed within the cam cover.

- Applications include: Audi (from 2017), Seat (from 2017), Skoda (from 2017) & Volkswagen (from 2017).
- Engine applications include: 1.5L TSi petrol engines - DACA, DACB, DADA, DFYA, DHFA, DPBA, DPCA & DPBE.
- Engine variants include: EA211, EVO 4 cylinder TSi ACT. Equivalent to OEM T10221-A.
- Recommended for use when performing timing checks and belt replacement - use with Laser engine timing kit, Part No. 8824.
- Supplied with water pump sprocket alignment pin to ensure correct alignment - use in accordance with OEM instructions. Made in Sheffield.
